Test Case Presentation

Altheim

Isar, Germany

Prepared by: Cornelia Häckl (Uniper)

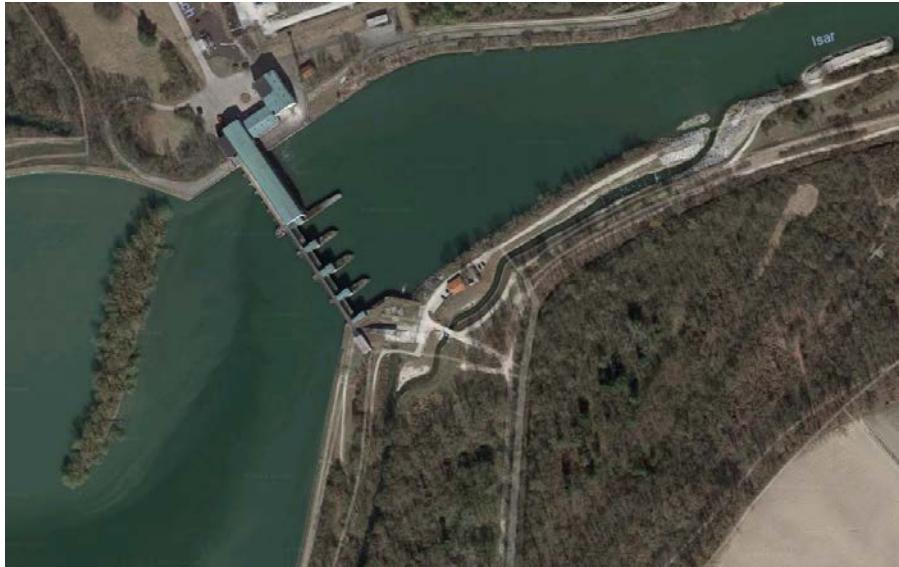
Figure 2: Top view of the HPP Altheim

The plant is located at km 67.2 of the river Isar near Altheim. Downstream of the test case site, 7 other HPP follow in the same water body.

The normal operating level is at 384,00 m above sea level, in hydropeaking mode it can be lowered by 1,00 m. On average there are 2 peaks per day, where the flow changes roughly between 50 m³/s and 170 m³/s with ramps of about 100 m³/s per hour or change of water level +45 cm/h or -30 cm/h. The plant has a head storage volume of 1980000 m³. The plant has 4 weir fields right of the power house.

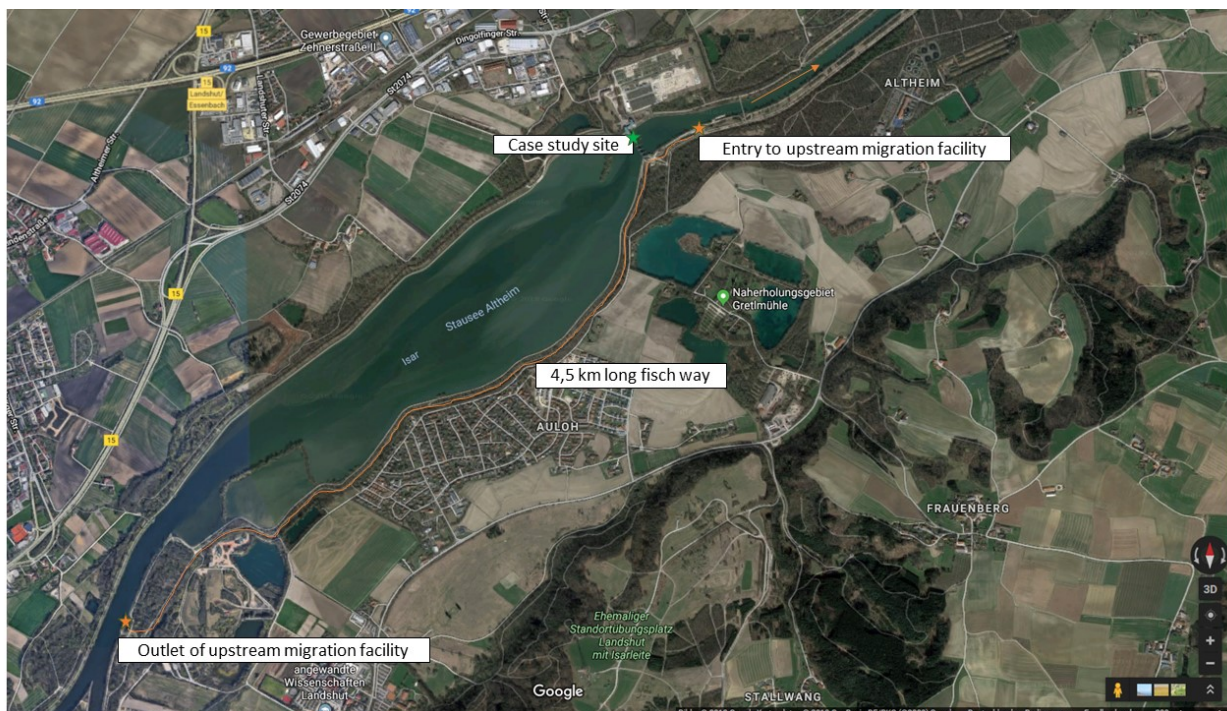
Figure 5: Location of the fishway at HPP Altheim

The upstream migration facility, which has been built in 2015, consists of a rough channel for the downstream connection at the entry of the fish pass. An existing drainage channel has been used to facilitate the fish passage over 4.5 km and for providing new hydromorphological structures and habitats in the fish pass. The fish pass entry is located on the right-hand side of the river Isar following the main migration route. On the upstream side a vertical slot connects the nature-like fish pass to the river. The vertical slot structure overcomes 1.45 m of height with 13 sections. The whole migration facility is always supplied with a minimum flow of 450 l/s (up to 800 l/s).

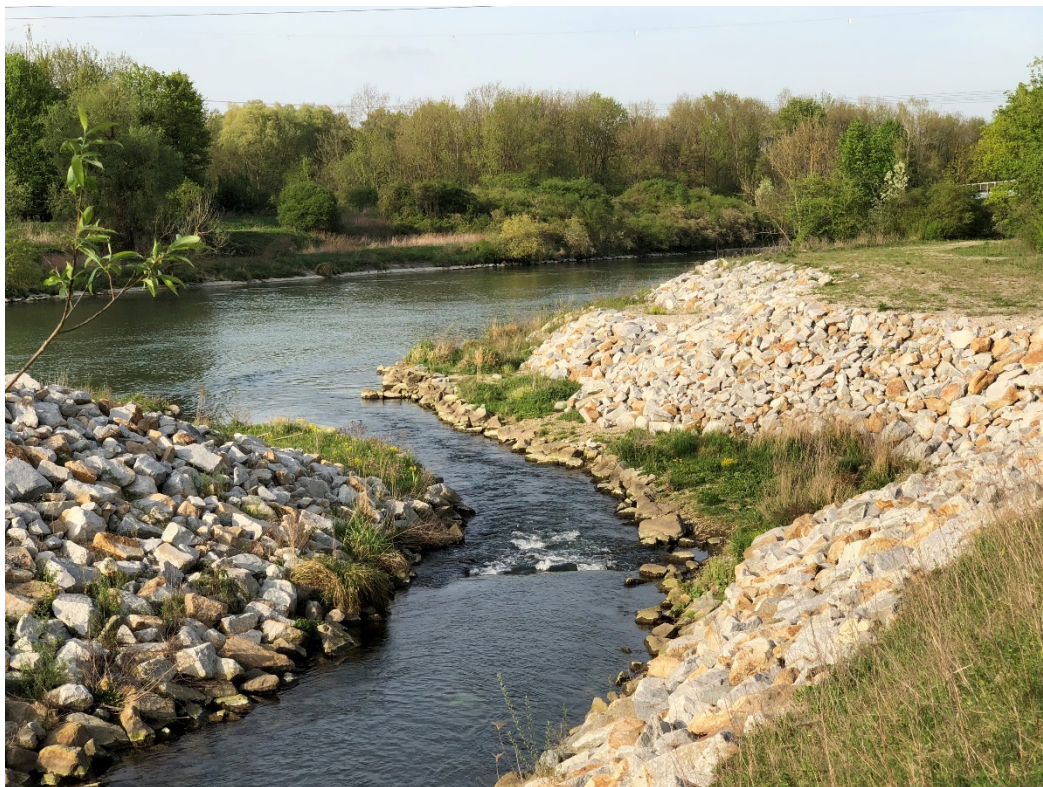
Figure 6: Entrance of the fish way downstream of the HPP Altheim

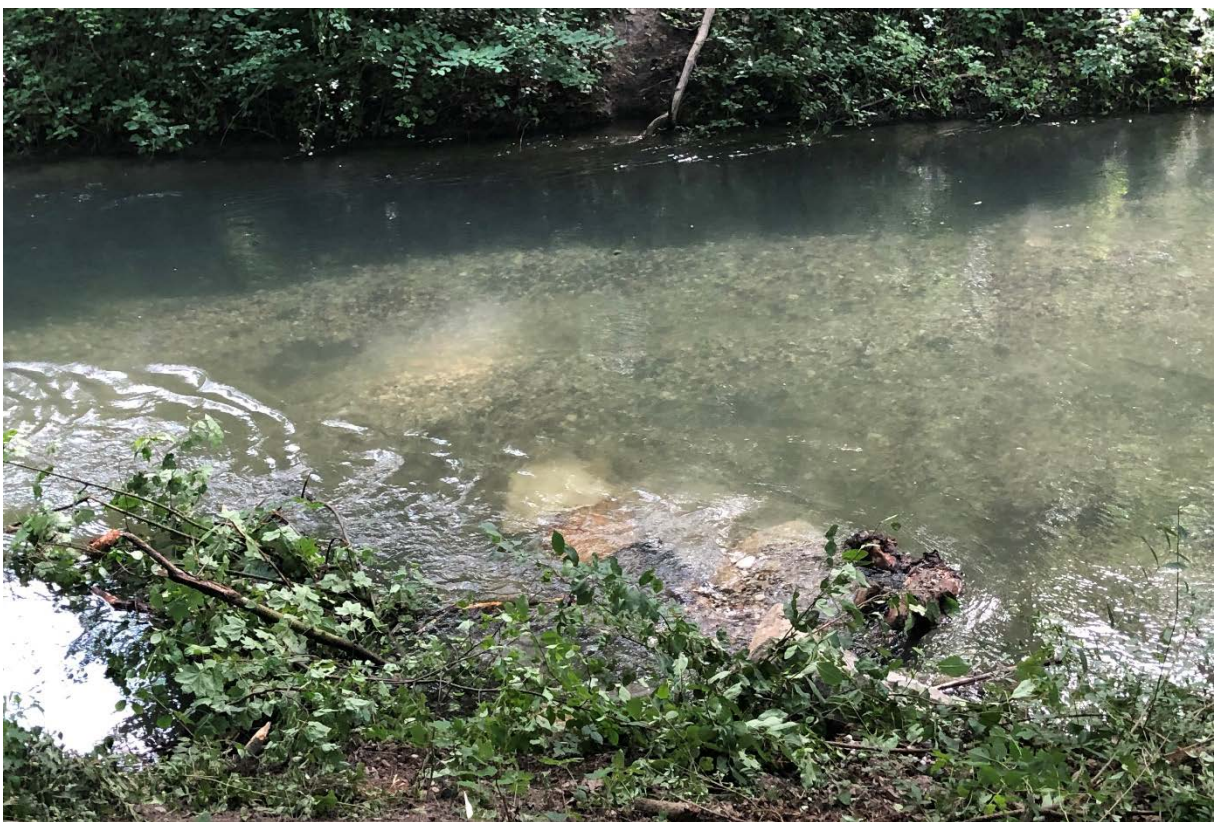
Figure 9: Structural measures for the improvement of habitat in the fishway. Top: adding of gravel; Bottom: deadwood and gravel banks

- Stone structures to vary the flow regimes: stone size mx. 80% of water depth, distance 50-60 cm
- Rhizomes in combination with block stones to imitate the availability of bulging and sliding slopes
- Dead wood structures to secure the banks

In autumn 2019, 37 structures were installed in the natural fish pass. The structures mainly consist of dead wood and spawning gravel and were constructed as spawning habitats, juvenile habitats or shelter but also to generally increase the variability in flow conditions.
